LT307 Lavatory shipped with incorrect wall mounting bracket

Models Affected

- **LT307** Lavatory with single hole
- **LT307.4** Lavatory with 4" faucet centers
- **LT307.8** Lavatory with 8" faucet centers
- **LT307A** Lavatory with single faucet hole and soap hole

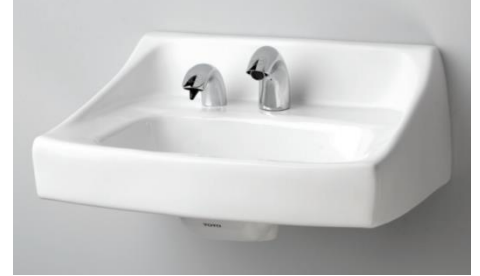
A: During routine product audit testing TOTO found that the wall mounting bracket supplied is incorrect. Given enough force the wall mounting bracket may bend causing the lavatory to become unlevel.

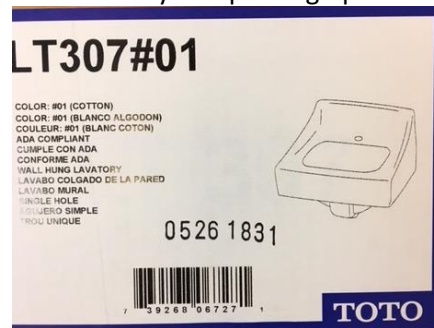
A: The image below represents the Date Code on the box. The first 2 characters are the month (05=May) the next 2 characters are the day (26=day of assembly), and the next 2 characters represent the year (18=2018). The final 2 characters represent the assembly and packing operator (31=Operator31).

A: The affected date range is June 1, 2017 to May 31, 2018 for models manufactured in the TOTO Mexico factory. The date code of assembly and packing is stamped on the box label.

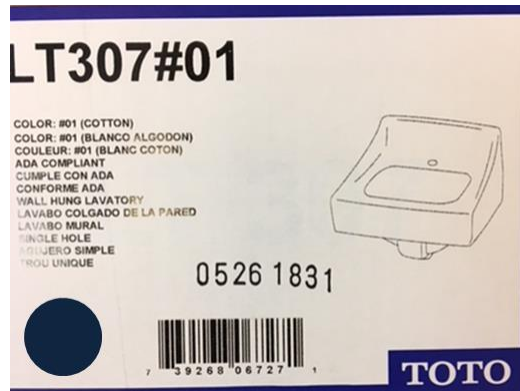
A: If there is blue dot on the product label then the wall mounting bracket in that box is correct. See the example below.

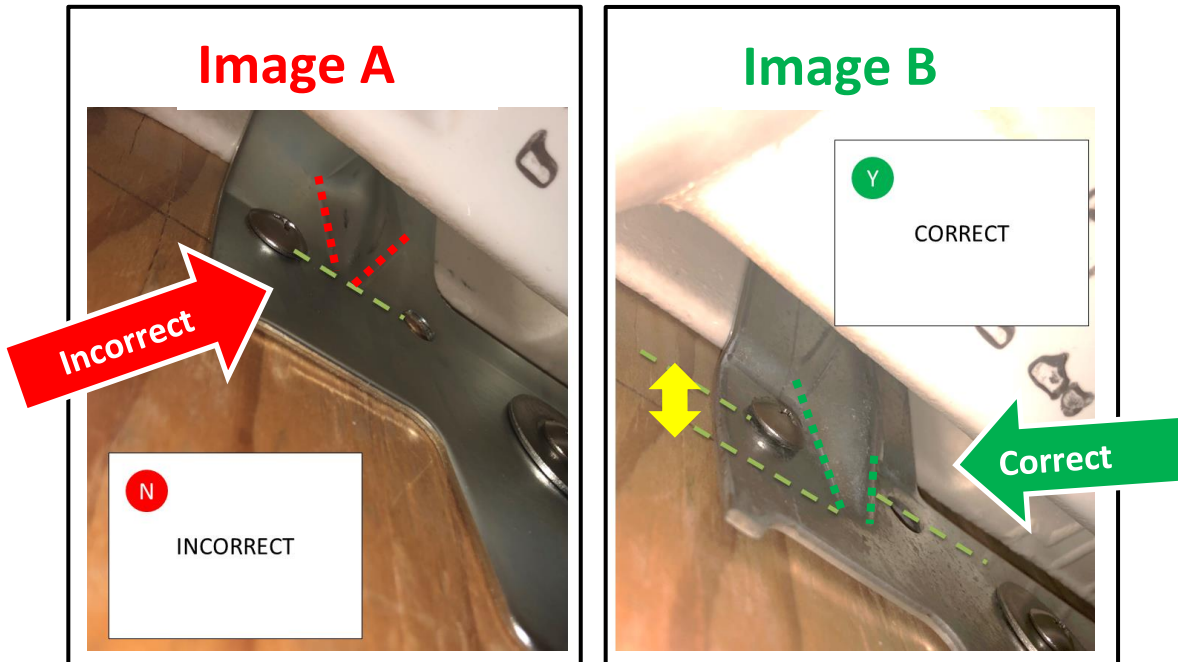
AFTER INSTALLATION

A: If the lavatory is installed, the wall mounting bracket should be inspected from underneath the installed lavatory. If the wall mounting bracket looks like **Image A** below, it is the incorrect bracket. **Important note:** If the lavatory is installed with the incorrect wall mounting bracket and there is a concealed arm system wall carrier installed also then no further action is required. If the incorrect wall mounting bracket is installed and there is not a concealed arm system wall carrier, then the unit should be removed and the correct wall mounting bracket installed. Please call TOTO at the number listed below for support of this change out.

Examine the bracket at underside of the installed lavatory. If it is the incorrect type of bracket it should be changed. Call TOTO Tech support as listed below to request a new correct Wall Mount Bracket.

Please note: If you have installed a concealed arm carrier there is no need to replace the incorrect bracket and no further action is required.

The Correct Wall Mounting Bracket Number 8BU002 – will be shipped from Tech Support upon request.
