LT307 Lavatory shipped with incorrect bracket

Models Affected

- **LT307** Lavatory with single hole
- **LT307.4** Lavatory with 4" faucet centers
- **LT307.8** Lavatory with 8" faucet centers
- **LT307A** Lavatory with single faucet hole and soap hole

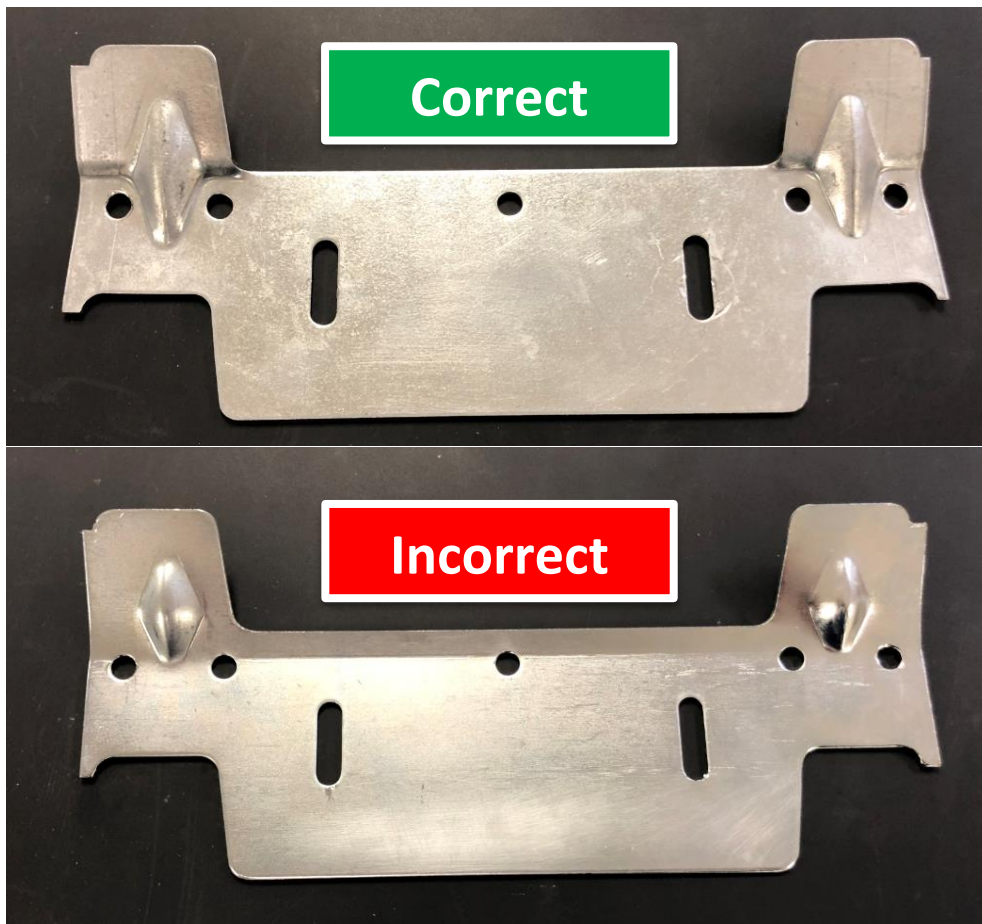
During the period from June 1, 2017 to May 31, 2018, LT307 model lavatories were packaged/boxed with an incorrect bracket.

Check the product label - if the date code reads in the range of June 1, 2017 to May 31, 2018, call TOTO Tech Support for a Return Goods Authorization (RGA) to allow for return of the entire LT307 product to TOTO. When the RGA is received, replacement product with the correct bracket will be sent to replace your inventory. The image below represents the Date Code on the box. The first 2 characters are the month (05=May) the next 2 characters are the day (26=day of assembly), and the next 2 characters represent the year (18=2018). The final 2 characters represent the assembly and packing operator (31=Operator31).

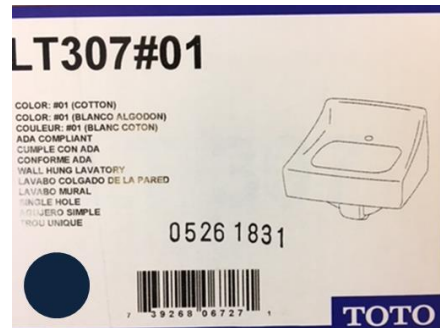
If there is blue dot on the product label then the wall mounting bracket in that box is correct. See the example below.

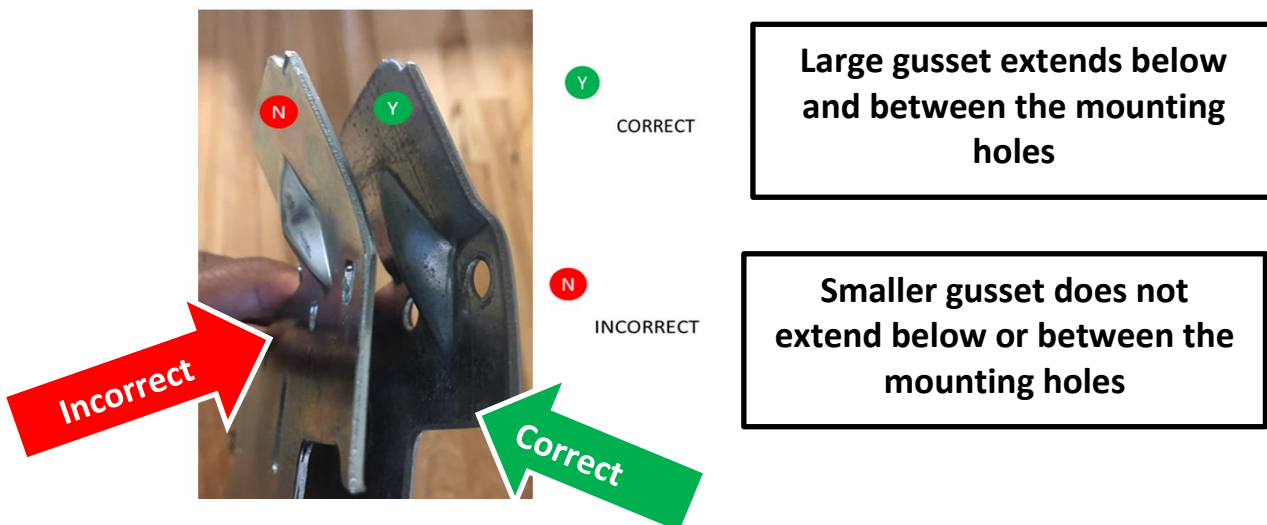
Check the bracket, and determine the positioning of the gusset. See image below. If you have the incorrect bracket please contact TOTO Tech Support and a new bracket will be sent.
