## A Brief Pictorial Guide to Weathered Finishes

### **Example: Weathered Copper Finish Changing Over Time**

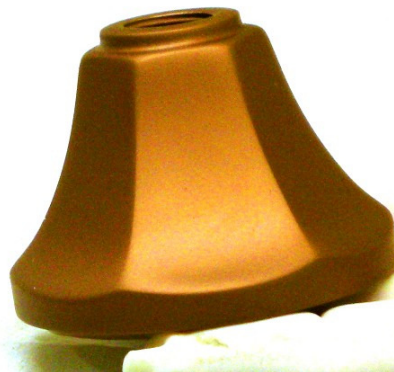
Weathered Copper fresh from plating. While it darkens over time, it begins lighter with more copper highlights.

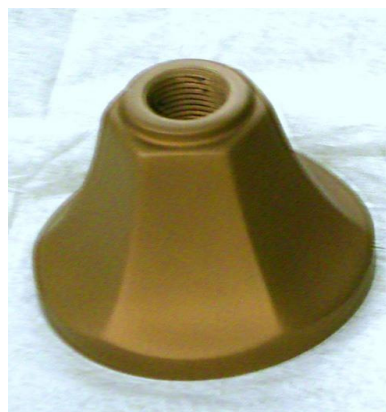
Weathered Copper at time of shipment from factory. Note how the finish has already begun to darken.

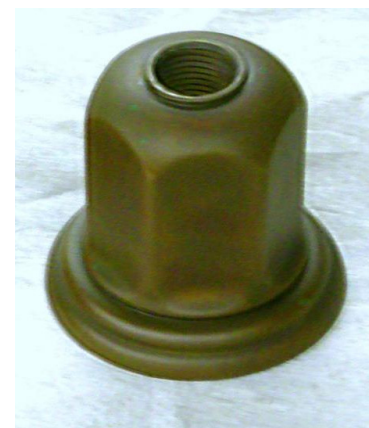
Weathered Copper six months after installation with proper care. (*subjected to water, cleaning, handling, etc.*)

The color can range from substantially lighter to substantially darker depending on a variety of factors.

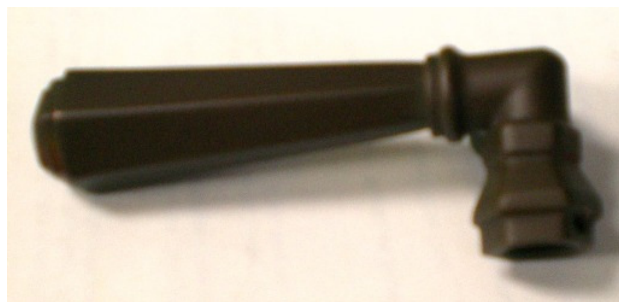
Weathered Copper after 1 year display in showroom. Showroom samples sometimes turn out darker than products in actual use as they do not have the same exposure to water, cleaning, etc. So never expect the purchased product to appear like the showroom sample.

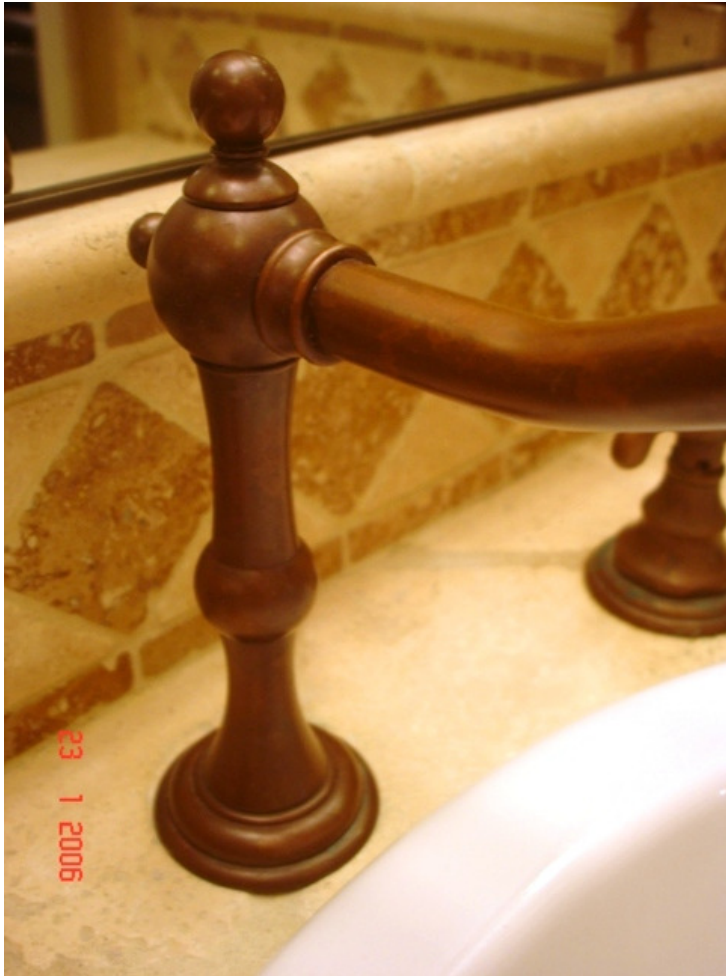
Excellent example of **Weathered Copper** faucet after 5 years of usage with proper care. The only cleaning given this faucet was a quick treatment with Renaissance Wax every week or two. Notice the variation in color between the spout and the spout ball, the minor specks of green on the escutcheon base, and the natural striations of copper color within each piece—this is all normal and natural and part of the desired patina for this unique finish.

To help ensure the best results, this particular faucet was waxed and aged in the garage for 1 week prior to installation and then was waxed again immediately after installation.

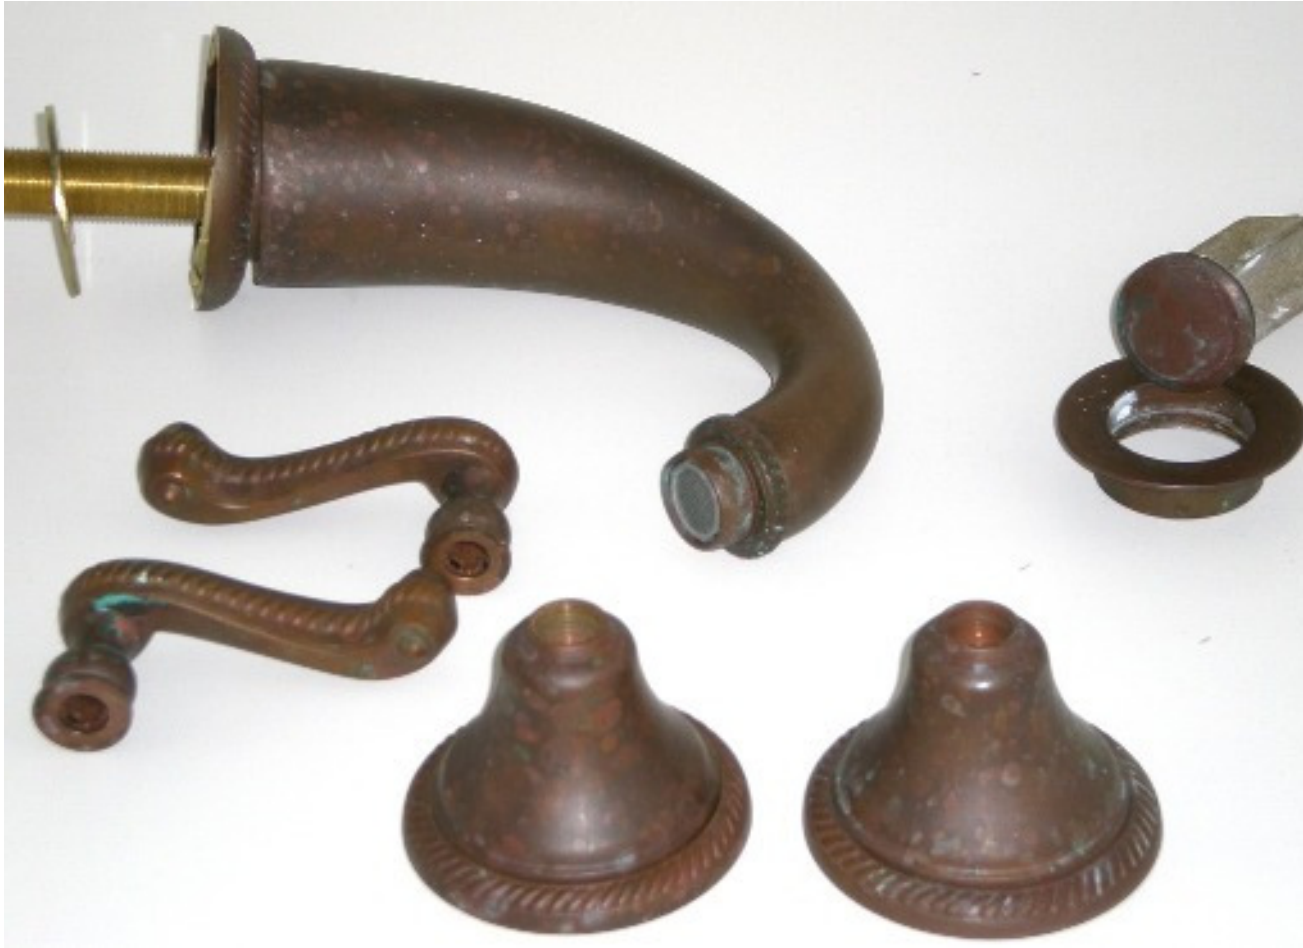
This faucet was part of an entire **Weathered Copper** bathroom that was returned to the factory as a “Defective Finish”. But there was nothing defective about the finish; this is simply an example of lack of proper care. Notice the heavy water spotting that caused the build-up of various minerals, scale and deposits. If you examine the parts carefully, you will notice that the underlying patina has developed nicely, but is marred by the spotting and staining created by lack of care. This problem is easily avoided by regular application of Renaissance Wax or other high quality, non-abrasive wax product.

The only care recommended for weathered finishes is the regular application of a wax such as **Renaissance Wax** or a high quality wax carnauba wax. The use of wax creates a barrier that protects the surface from moisture, oxygen and contaminating elements from handling & use. This helps prevent the build up of water spots and promotes a more even, natural patina. Apply a small amount of wax and buff with a clean, soft, lint-free cloth.

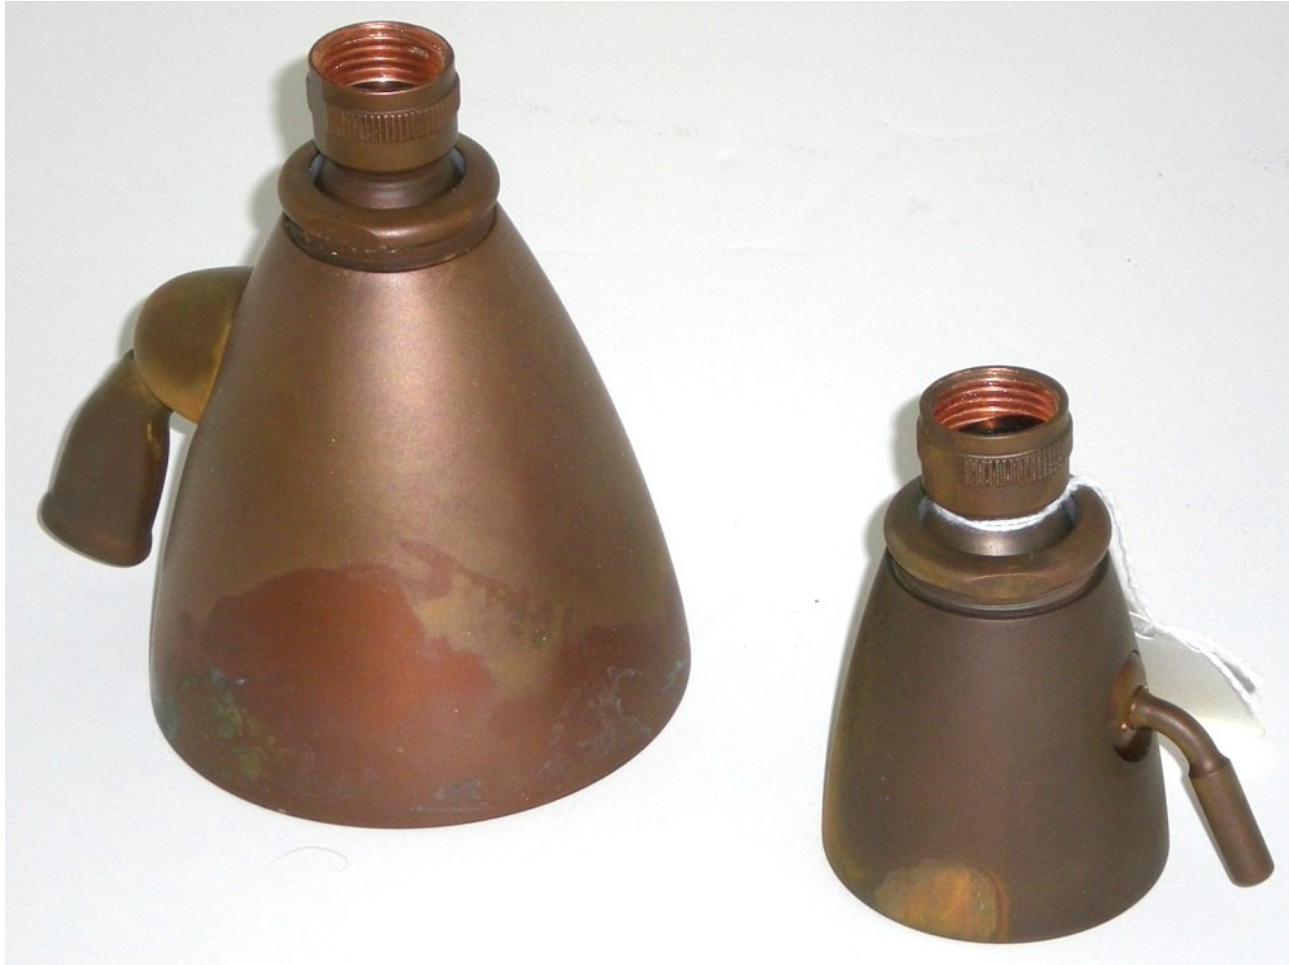
The above showerheads are examples of **Weathered Copper** with true finish defects. Notice that the showerheads have not yet been installed, but have developed prominent staining and severe color variation.
